Tontitown Sewer Evaluation Report

City of Tontitown

Date: 8-28-2025

CK Civil Engineering, LLC

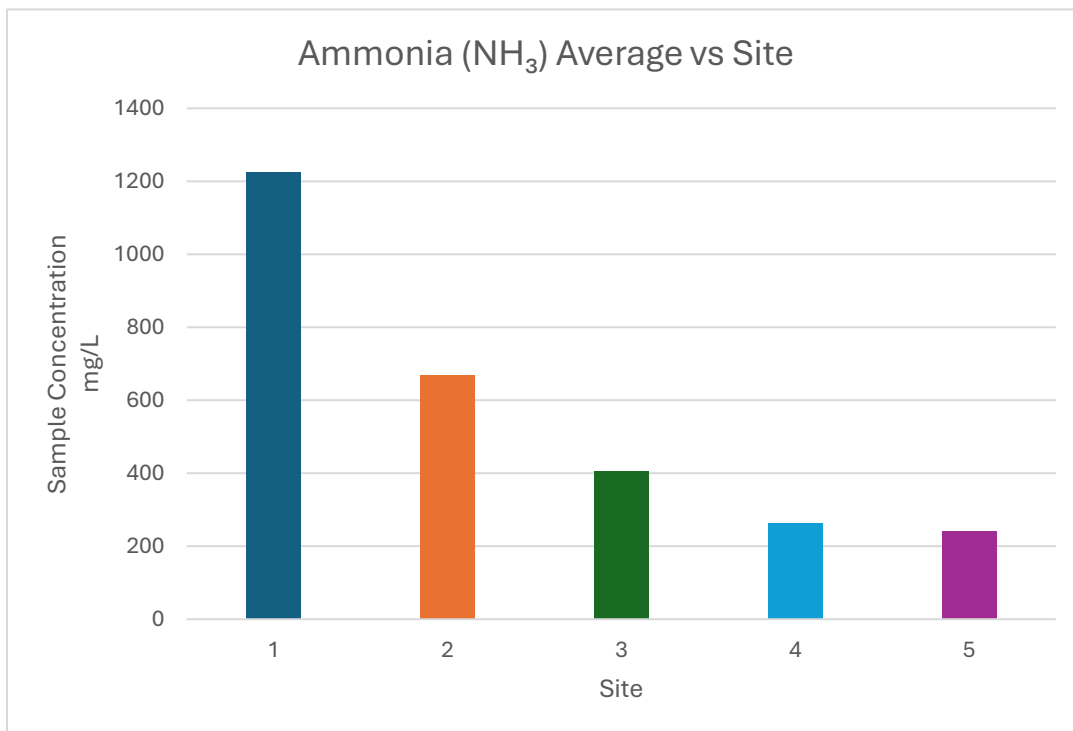
Figure 1 : Ammonia Average vs. Site

As part of the study, water sample testing was conducted. Samples were collected from five sites across the sewer line under evaluation. The sites were: Pianalto Lift Station, Sanitary Manhole MV1, Sanitary Manhole MM3, Sanitary Manhole MS7, and the Barrington Lift Station. There were 21 sets of data over 7 days with 3 data sets for each day. The data varies depending on the time of day, but the trends are consistent over the 1-week period. The data shows that almost all of the data points were below the 1000 ppm ammonia level that ADEQ stated in its formal request. Most of the data samples that were above 1000 ppm were from Site 1, also known as the Pianalto Lift Station. Only 5 data samples were above 1000 ppm and not from the Pianalto Lift Station; these were from Site 2 and Site 3. These sites are the closest to the landfill. Most of the data, especially from sites 3-5, was well below the 1000 ppm level. Ammonia concentrations drop further away from the Pianalto Lift Station.

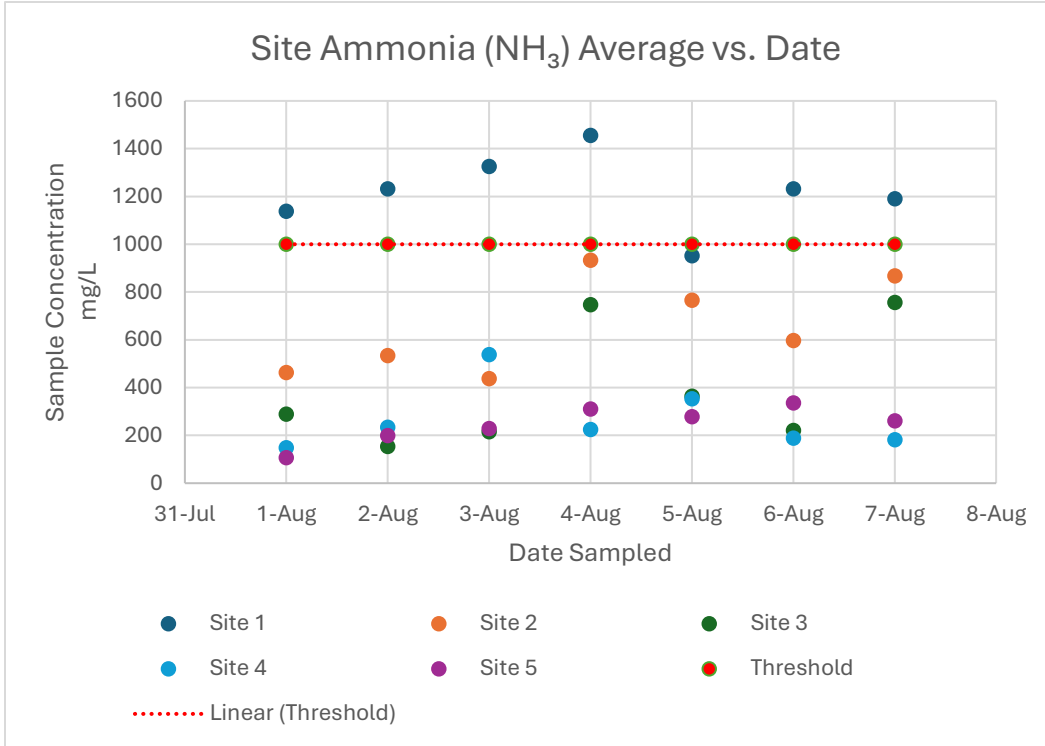
Figure 2 : Site Ammonia Average vs. Date

One notable uptick in ammonia concentration was observed on the fourth day of observation, Monday, August 4th, 2025. This increase in concentration registered at all sites across the system and represented the highest observed data during the evaluation. It is unknown as to the cause in higher ammonia concentration was observed this day.
